MISCELLANEOUS PAPER SL-81-20

EXAMINATION OF ERDA-10 GROUT SPECIMENS AT DIFFERENT AGES

Structures Laboratory
U. S. Army Engineer Waterways Experiment Station
P. O. Box 631, Vicksburg, Miss. 39180

August 1981

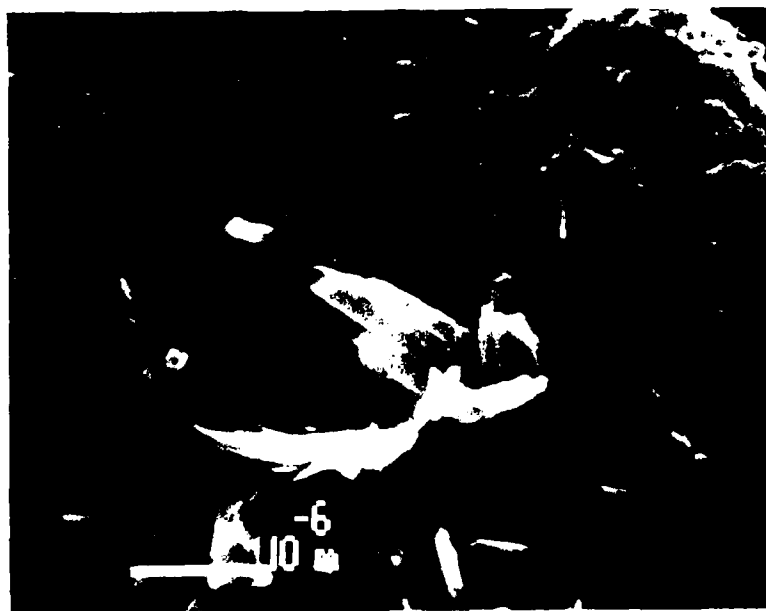
Figure 12. Micrograph 122380-8 (X20,000). Higher magnification of void in Figure 11. Void is partially filled with ettringite crystals. The bar is 1 μ m long

13. Figures 9 through 12 show four micrographs of the 38-month-old fresh water plug 4 grout at magnifications ranging from 500X to 20,000X. Comparison with Figures 1 through 8 show that the plug 4 grout has a denser structure. This is believed to be due to its lower water to solids ratio (0.49).^(1,2) The microstructure of this plug 4 grout is more like that of the normal consistency paste with 30 percent fly ash shown in Photomicrographs 11 and 12 of Appendix A than the same age grouts made with salt.

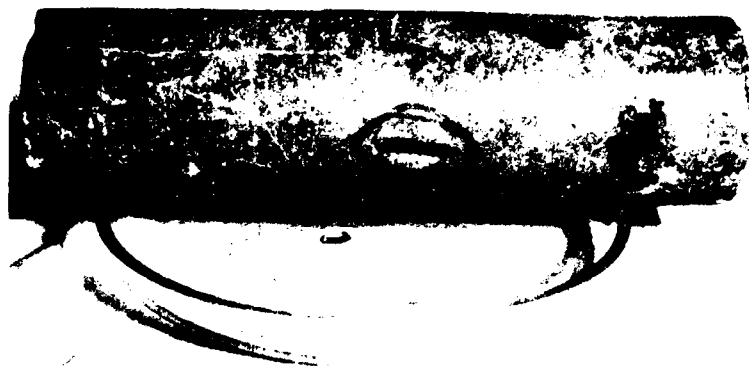
Figure 15. Plug 1 3-in.-diameter grout core after about 41 months in brine at 100^o F. Several filled cracks are evident; these include vertical, horizontal, and diagonal cracks

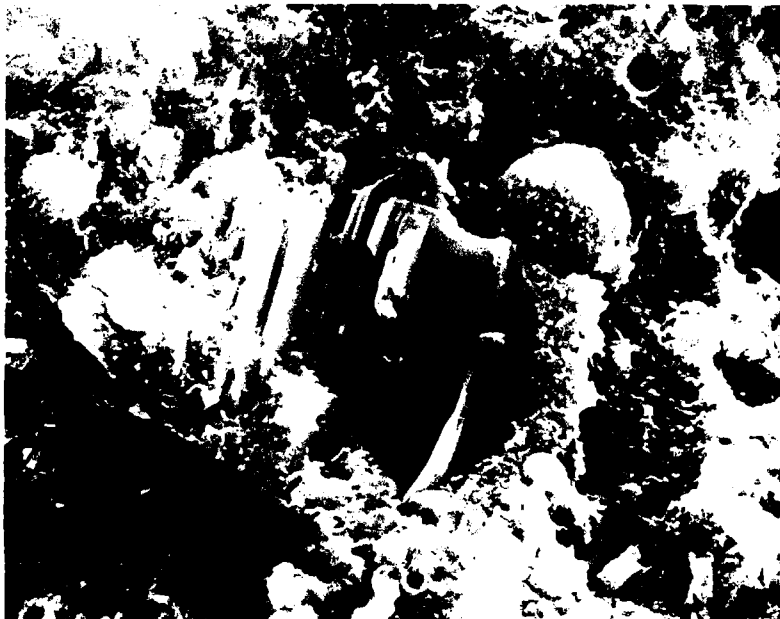
Photomicrograph 6b. A portion of 6a at X2000. Compare with 2b, 4b, and 5b
